Manhole Inspection Summary

Manhole # S45MM_012MH

Insp Date: **3/26/08 9:13 AM**

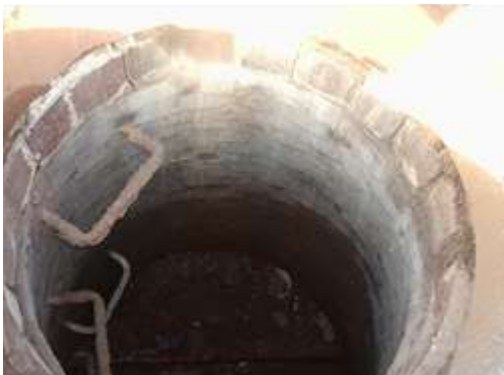
Defect 1

Condition: ☐ Sound ☐ Cracked ☐ Root Intrusion ☒ **Loose Brick** ☐ Deteriorated

Infiltration: ☐ None ☐ Joint ☐ Cracks ☒ **Mortar** ☐ Roots ☒ **Wall**

adjustment joint

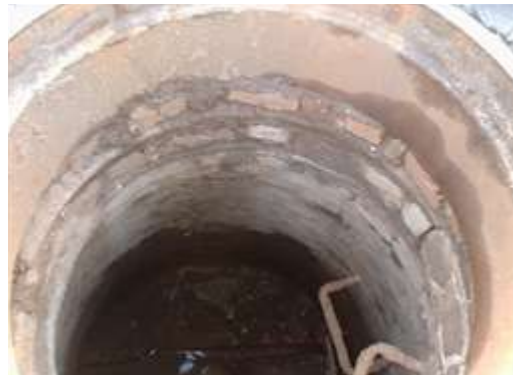
Defect 2

Frame Offset: **1** (in.) Condition: ☐ Sound ☐ Cracked ☒ **Leaks**

frame leaks

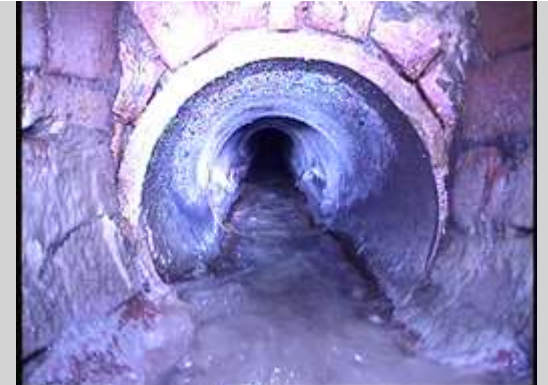
12 O'Clock Outflow

10 in. Circular Gravity Sewer
Pipe Out @ 12 O'Clock

Pipe Height: **9.6** (in.) Rod and Bar (Angled)
Pipe Material: **Clay** ☐ Pipe Lined
Invert Depth: **8.80** (ft.) Flow Characteristics: **Fast**
Deposits: ☒ None ☐ Mud ☐ Sludge ☐ Debris ☐ Grease
Silt Depth: (in.) Deposits Extent:
Infiltration: **None** Pipe Seal Cond: **Sound**

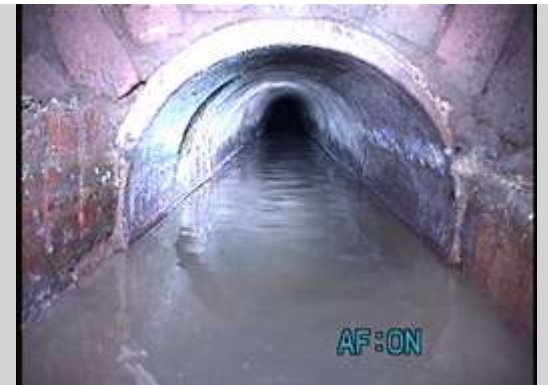
6 O'Clock Inflow

In pipe is bigger than out pipe.

12 in. Circular Gravity Sewer
Pipe In @ 6 O'Clock

Pipe Height: **12** (in.) Rod and Bar (Angled)
Pipe Material: **Clay** ☐ Pipe Lined
Invert Depth: **8.40** (ft.) Flow Characteristics: **Fast**
Deposits: ☒ None ☐ Mud ☐ Sludge ☐ Debris ☐ Grease
Silt Depth: (in.) Deposits Extent:
Infiltration: **None** Pipe Seal Cond: **Sound**
